# Debris/Ice/TPS Assessment And Photographic Analysis For Shuttle Mission STS-42

March 1992

National Aeronautics and  
Space Administration

**Gregory N. Katnik**  
**NASA/Kennedy Space Center**

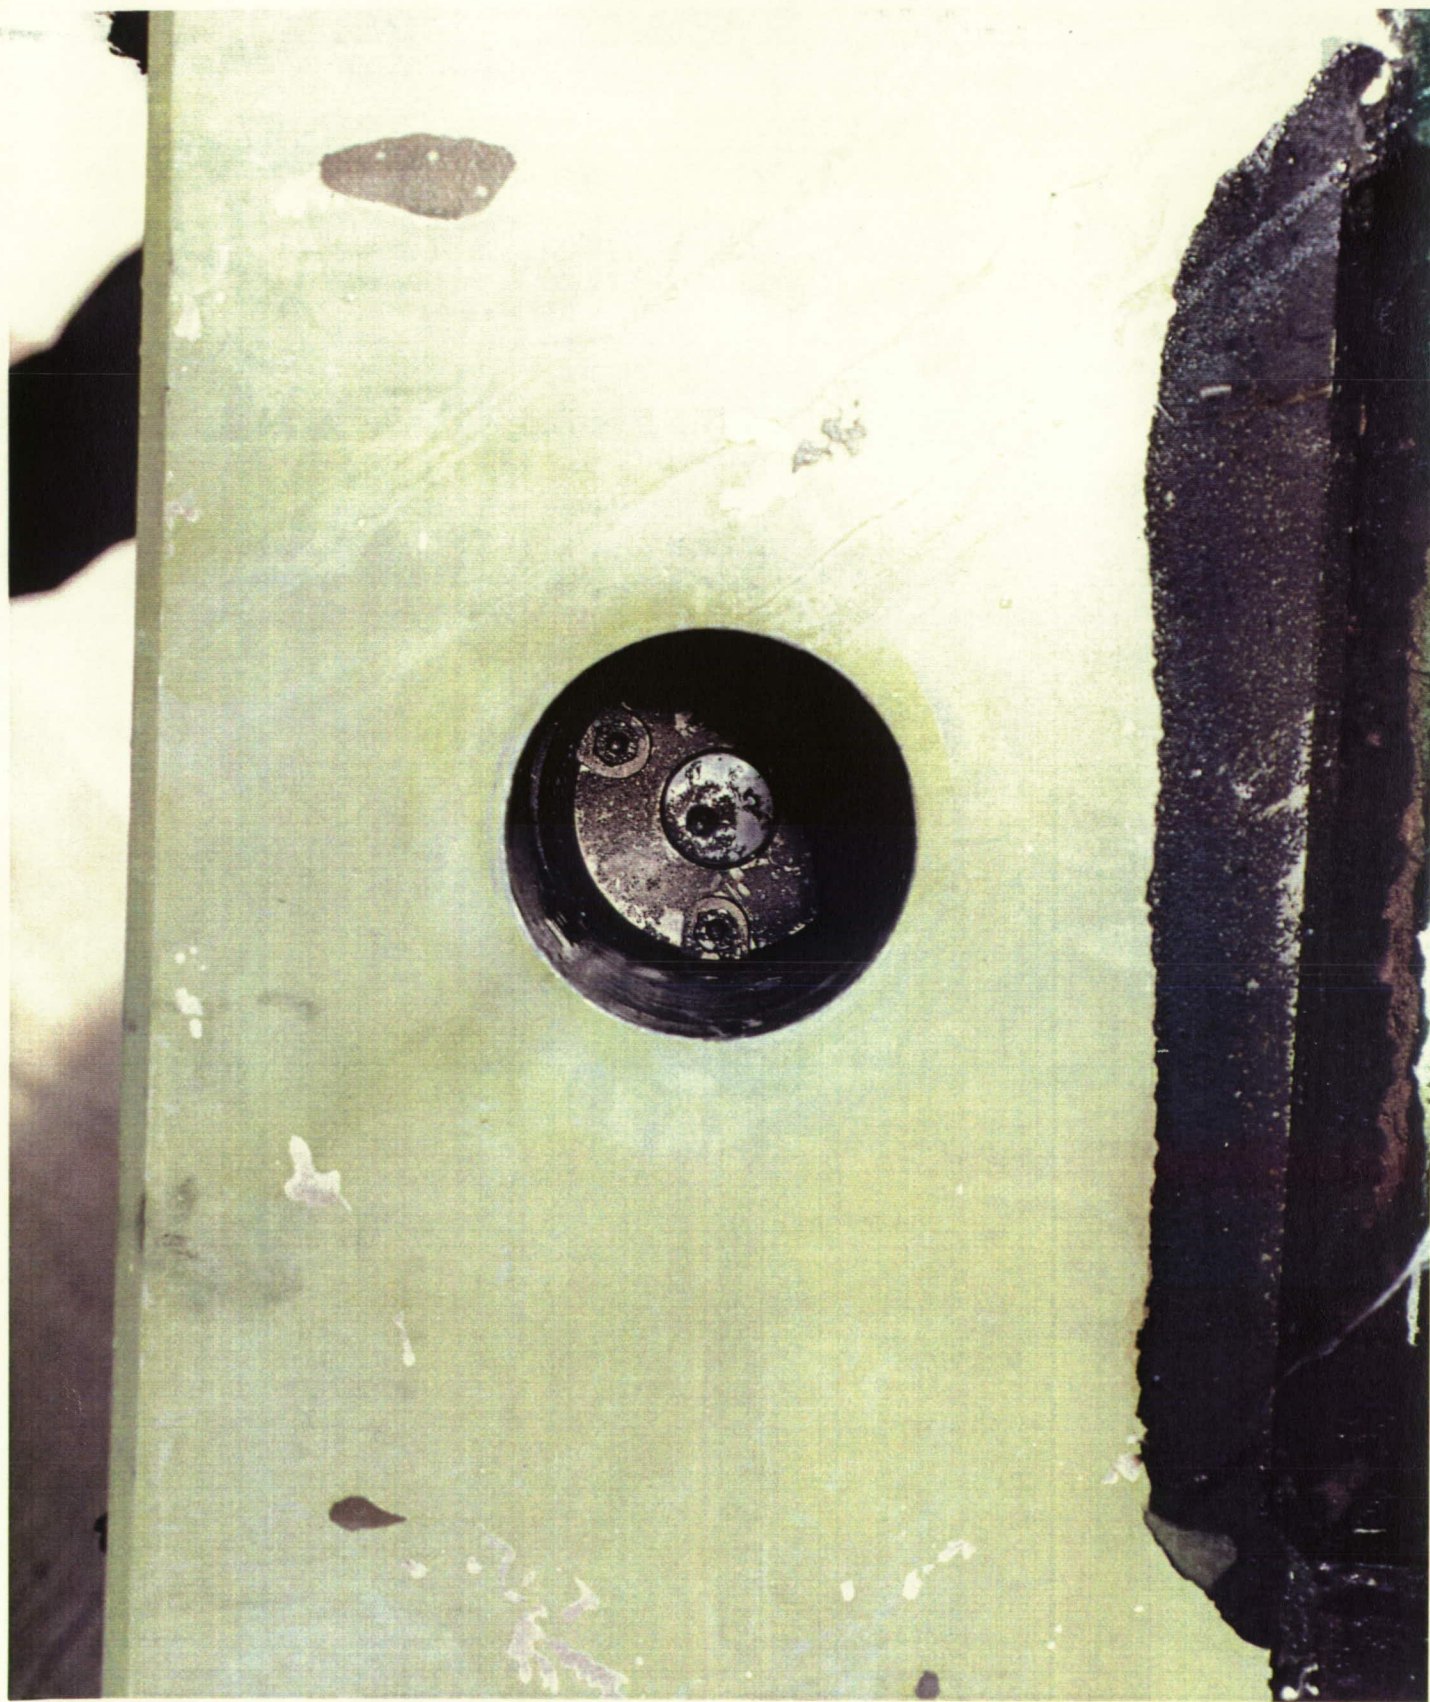
All four HDP Debris Containment System plungers were seated. There was no sign of broaching in any of the stud holes. Approximately 10 percent of the HDP #7 EPON shim was missing prior to splashdown and the substrate was charred.

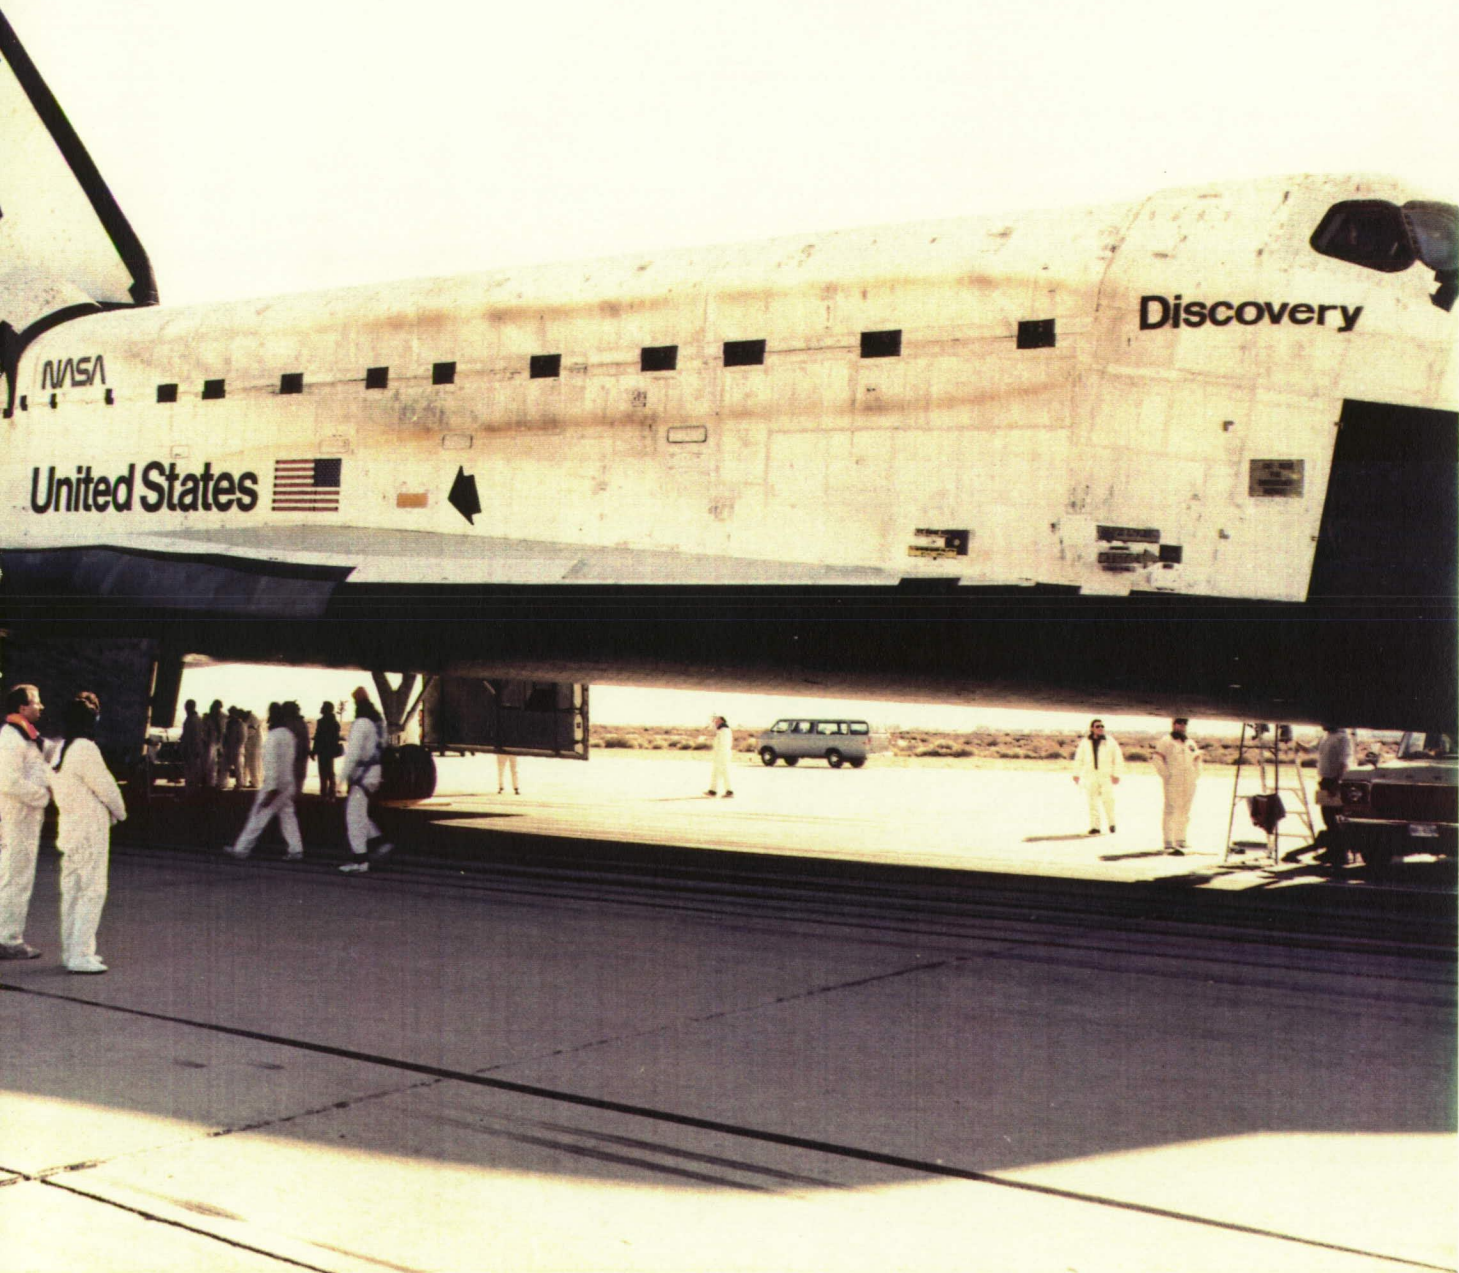
Overall view of Orbiter right side. Streaks on payload bay door and fuselage may be related to on-orbit leak of aft RCS thruster. Note yellow discoloration of vent door #7.

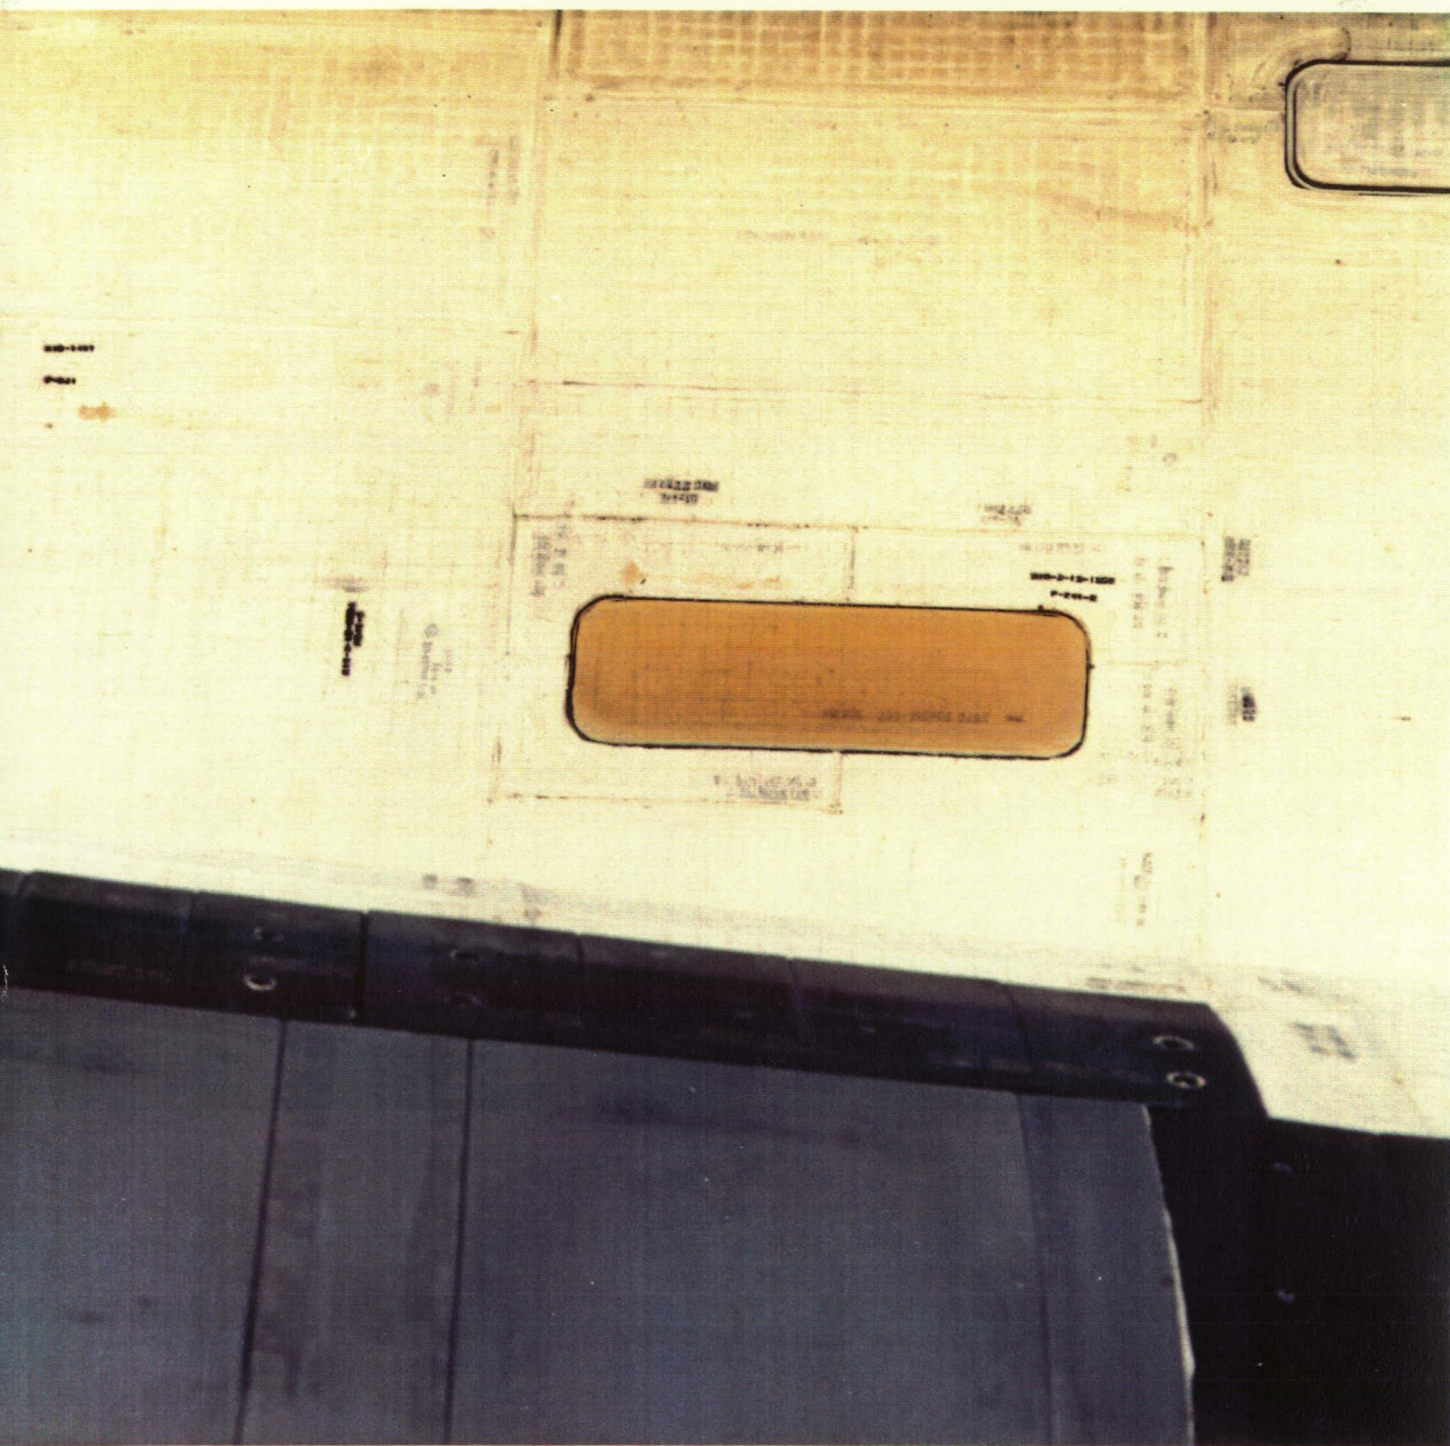
Additional testing performed for this mission included specially removed damaged tiles for testing at MSFC and the discolored RH vent door #7. The MSFC testing is not complete yet but the early results (non-destructive tests) do not show indications of debris particulate. KSC analysis showed the vent door discoloring was not a debris concern.

A hydraulic fluid leak was eliminated as a possible cause of the yellow discoloration on vent door #7. The most likely cause is believed to be a reaction of the RTV bonding agent through the flexible insulation blanket and thermal barrier.

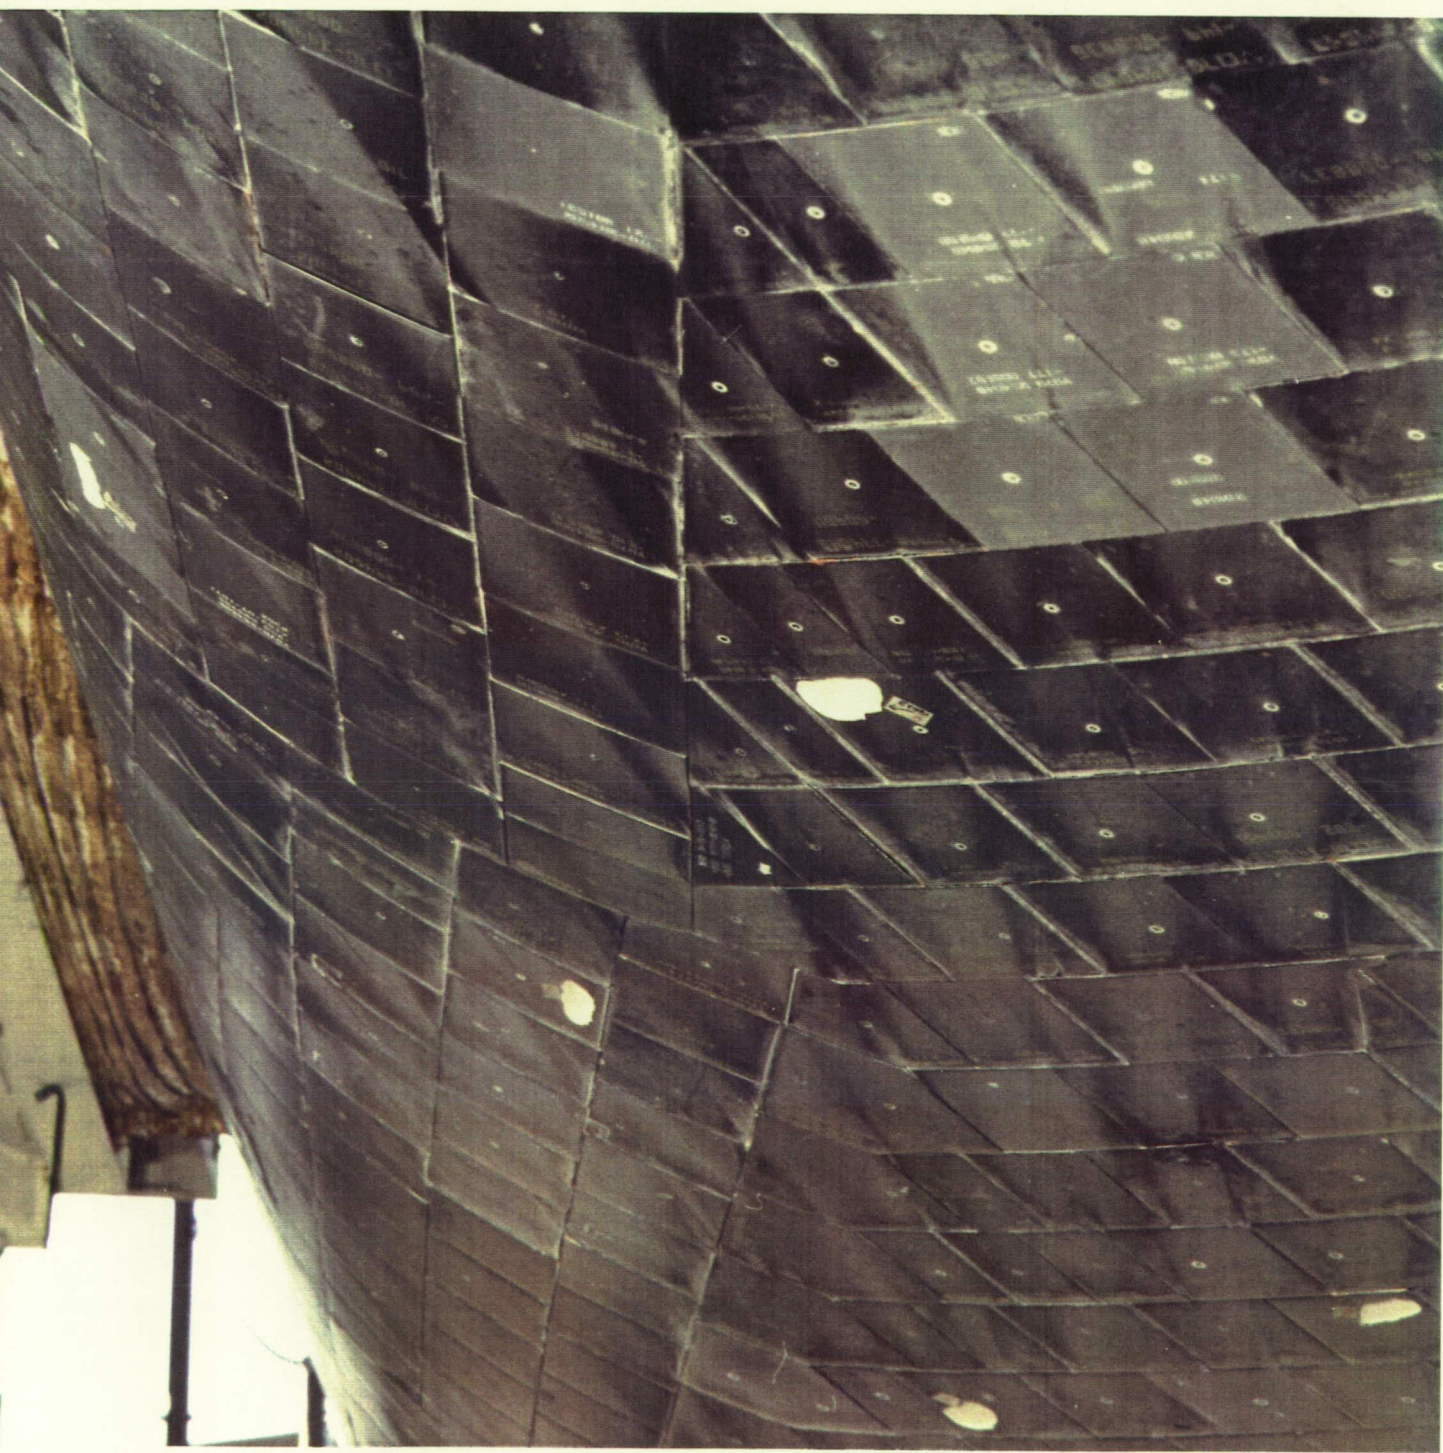
SOFI debris from the External Tank intertank and/or lower L02 tank is the most likely cause of the excessive Orbiter tile damage.

All of the tile hits on the lower surface were shallow (3/8 inch or less) relative to the surface area. This type of tile damage is indicative of impact by a low density material. As a result of this tile damage, a debris damage/source investigation was conducted. Post flight inspections of the Orbiter and recovered SRB's revealed no loss of TPS or flight hardware. The TPS on the SRB's is more dense and results in deeper penetration. A mechanism to transport ET intertank foam to the Orbiter forward lower surface area had been previously demonstrated. ET-52 was the second tank flown with the new two-gun spray process on the intertank. IFA STS-42-T-001 was taken against the loss of ET intertank foam as the probable source for the debris damage to Orbiter tiles on STS-42.

Tile damage on the lower surface near the Orbiter nose generally consisted of shallow damage sites ( $3/8$ -inch or less) relative to the surface area. This type of tile damage is indicative of impact by low density material.

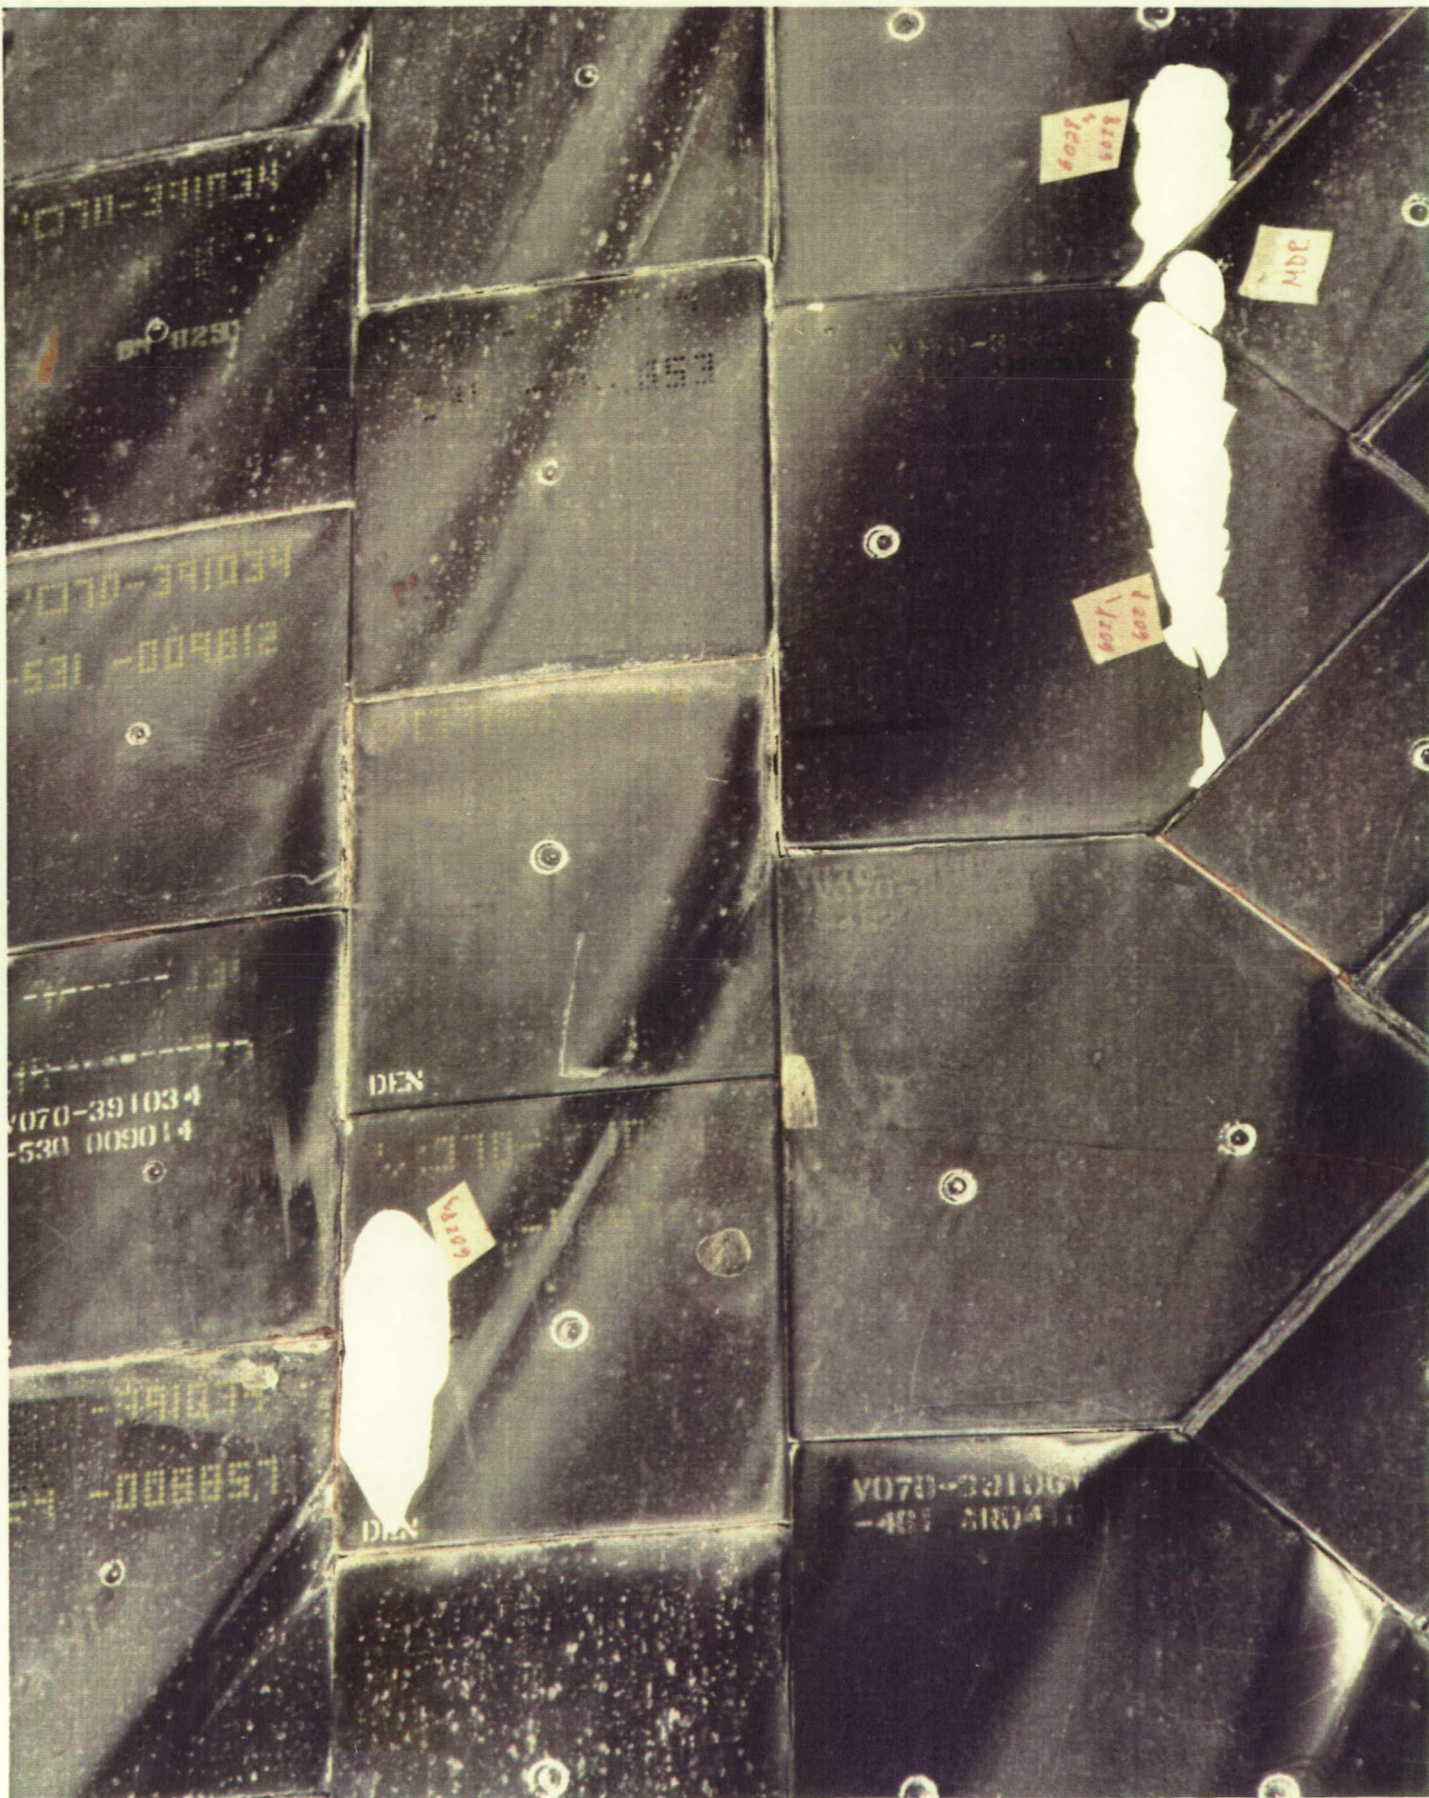
The largest tile damage site (10-3/4" x 1-3/8" x 1/4") occurred on the forward right hand side of the Orbiter lower surface

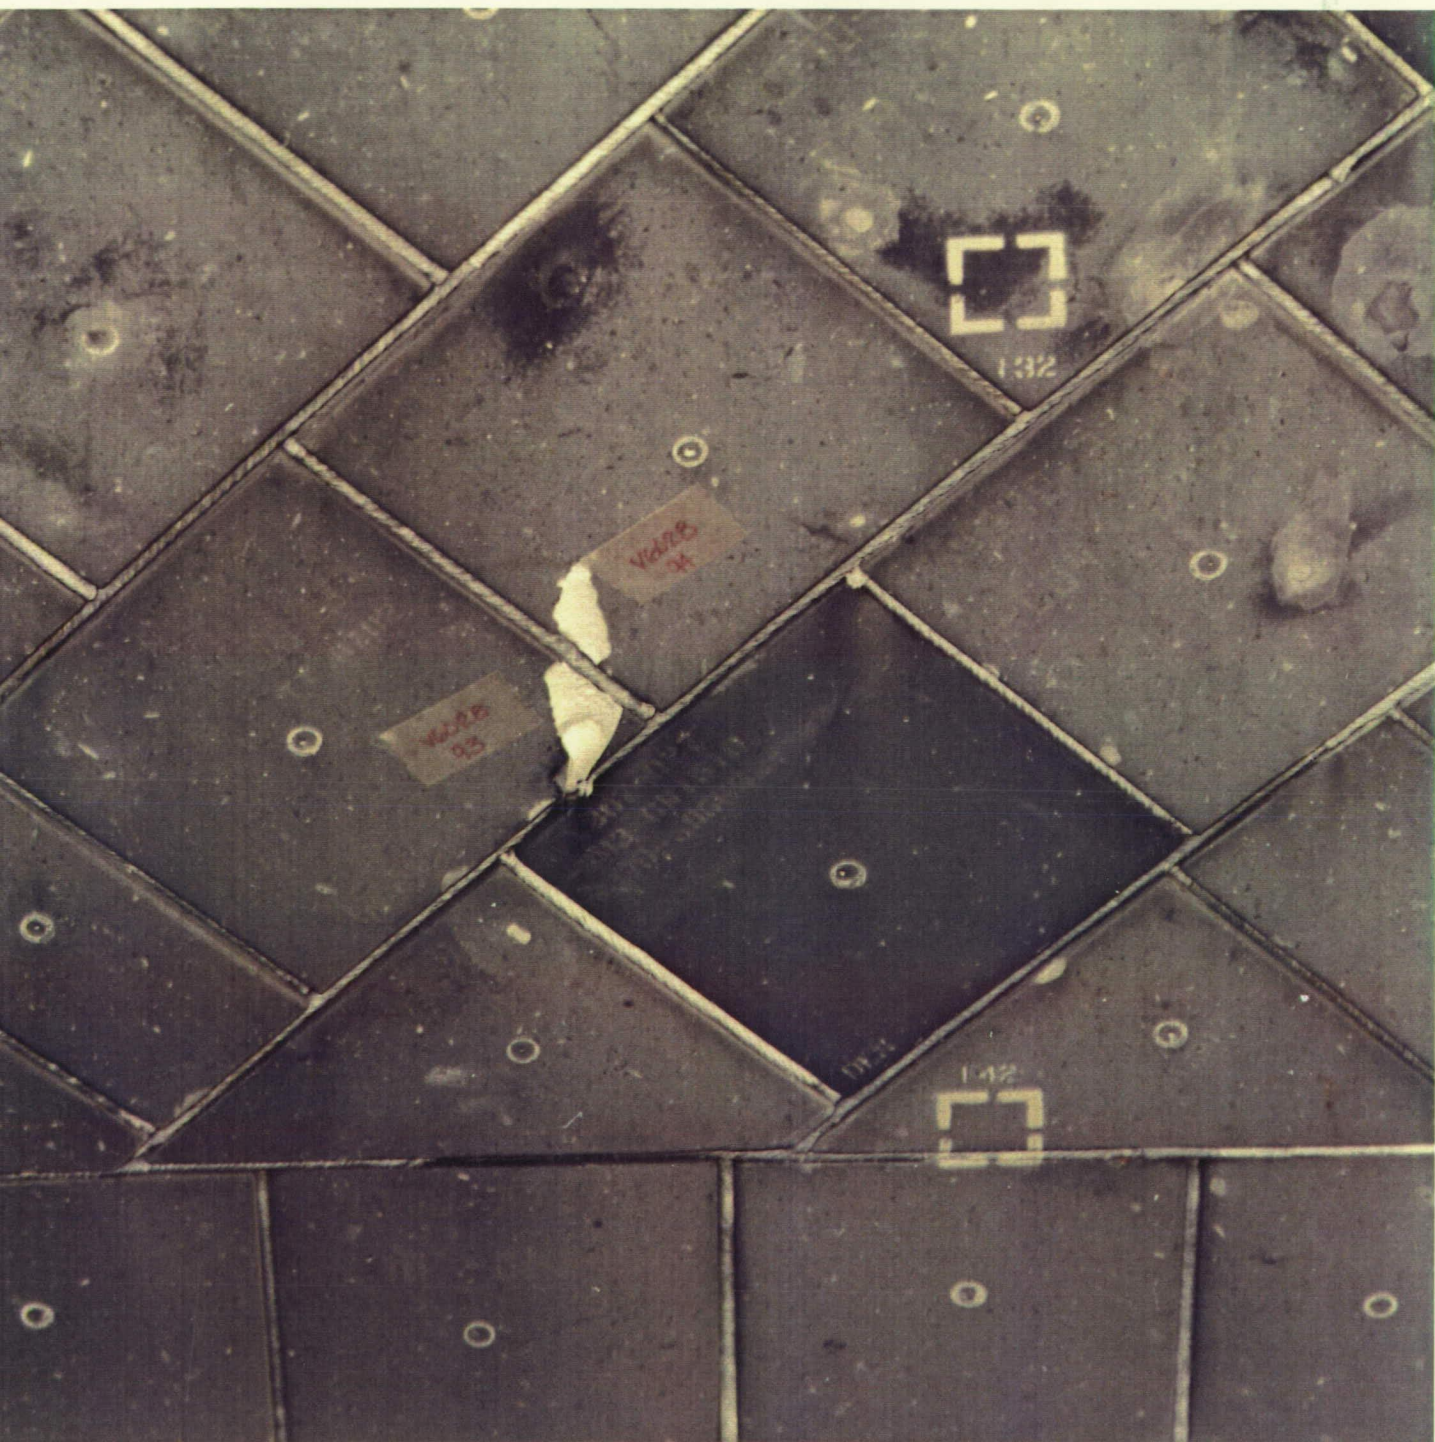
Typical tile damage on the Orbiter aft lower surface exhibited minor thermal erosion.

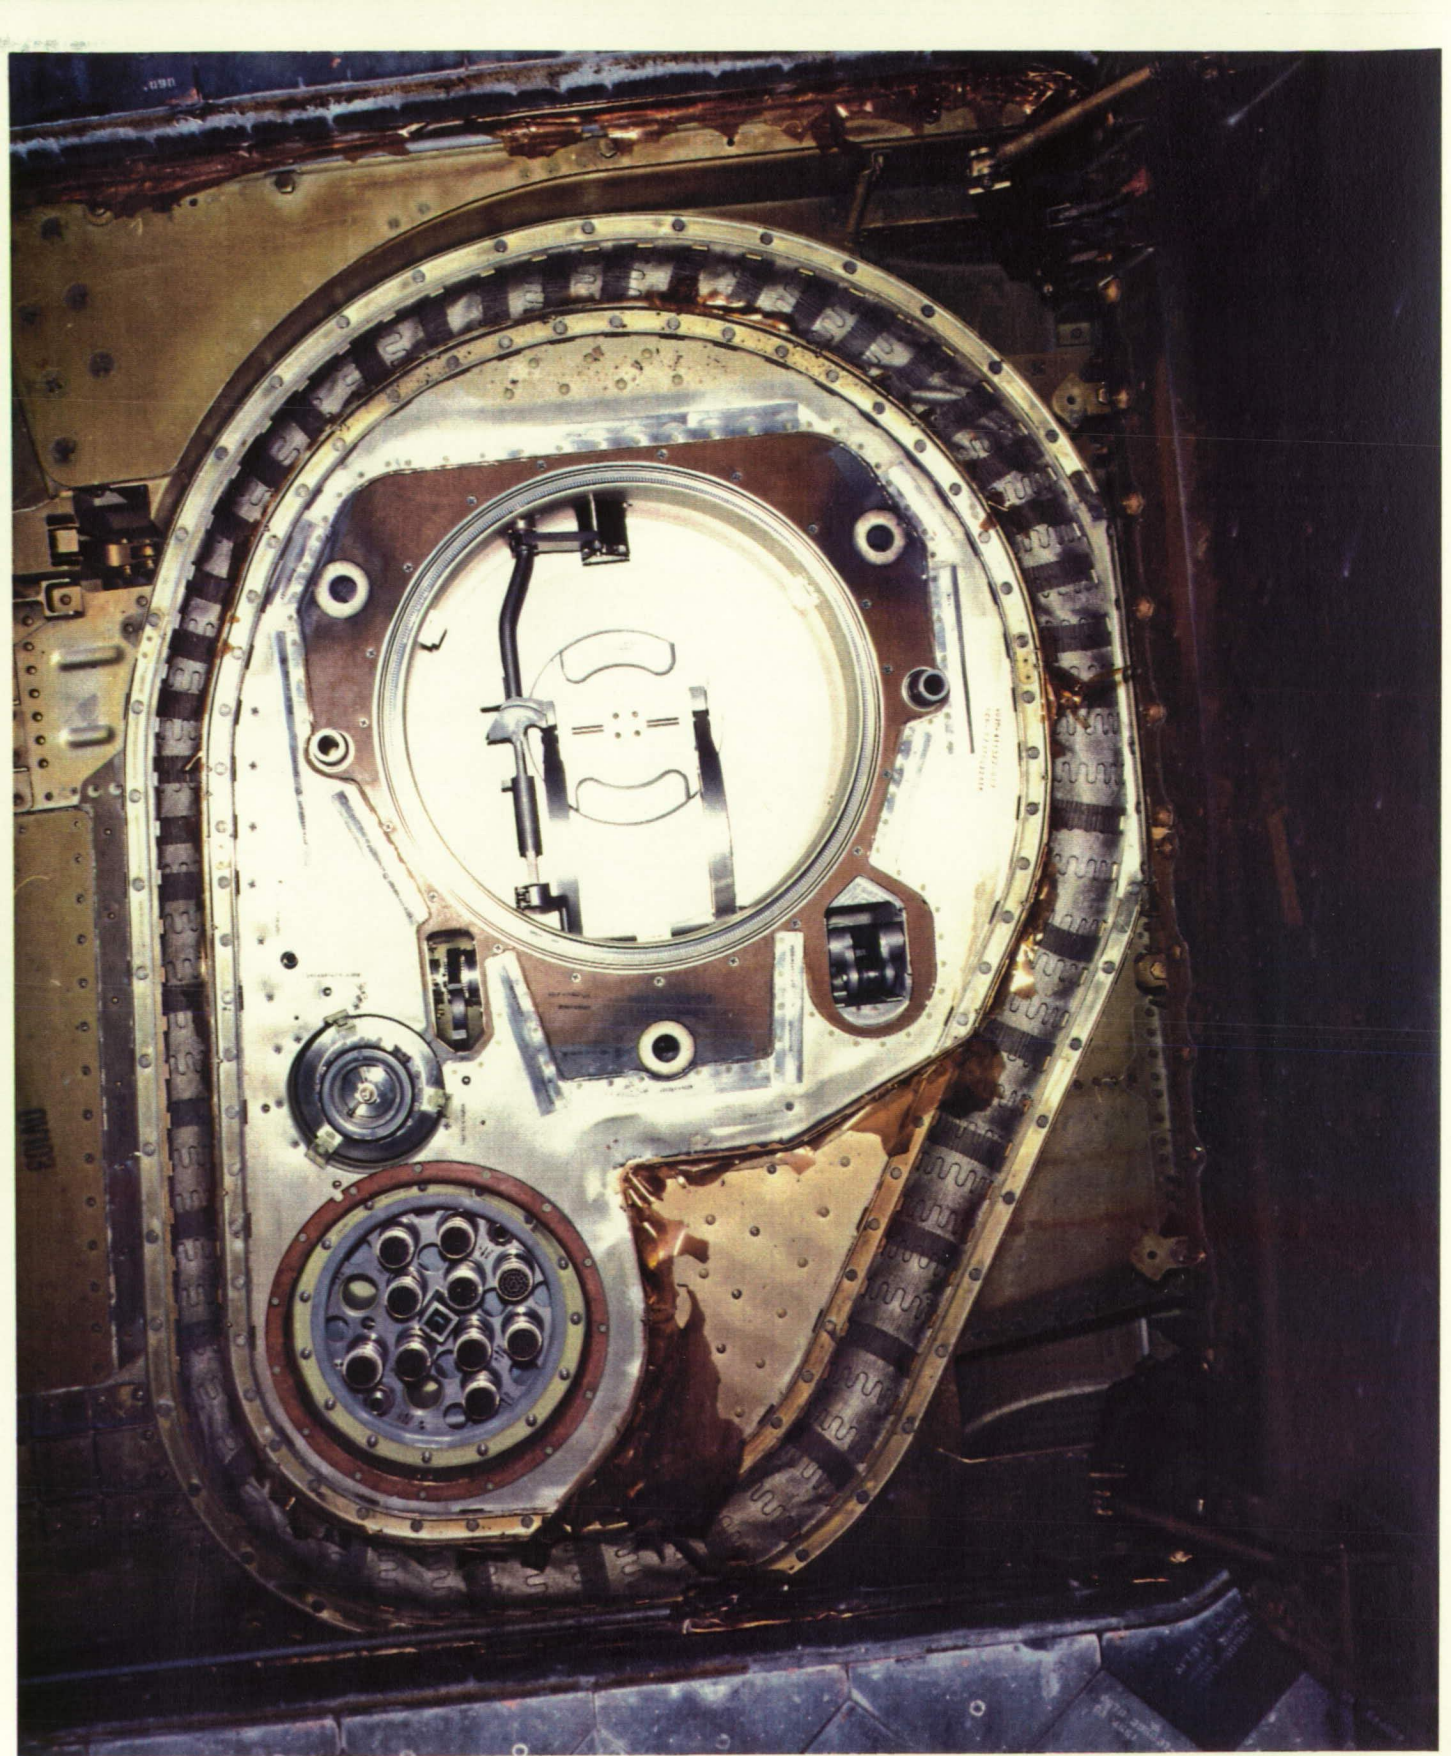
Overall view of the LO2 ET/ORB umbilical. The separation ordnance device debris plunger in EO-3 was seated and appeared to have functioned properly. Wrinkling of the interface plate, particularly near the aft separation bolt hole, was attributed to shrinkage during cryogenic chilldown.

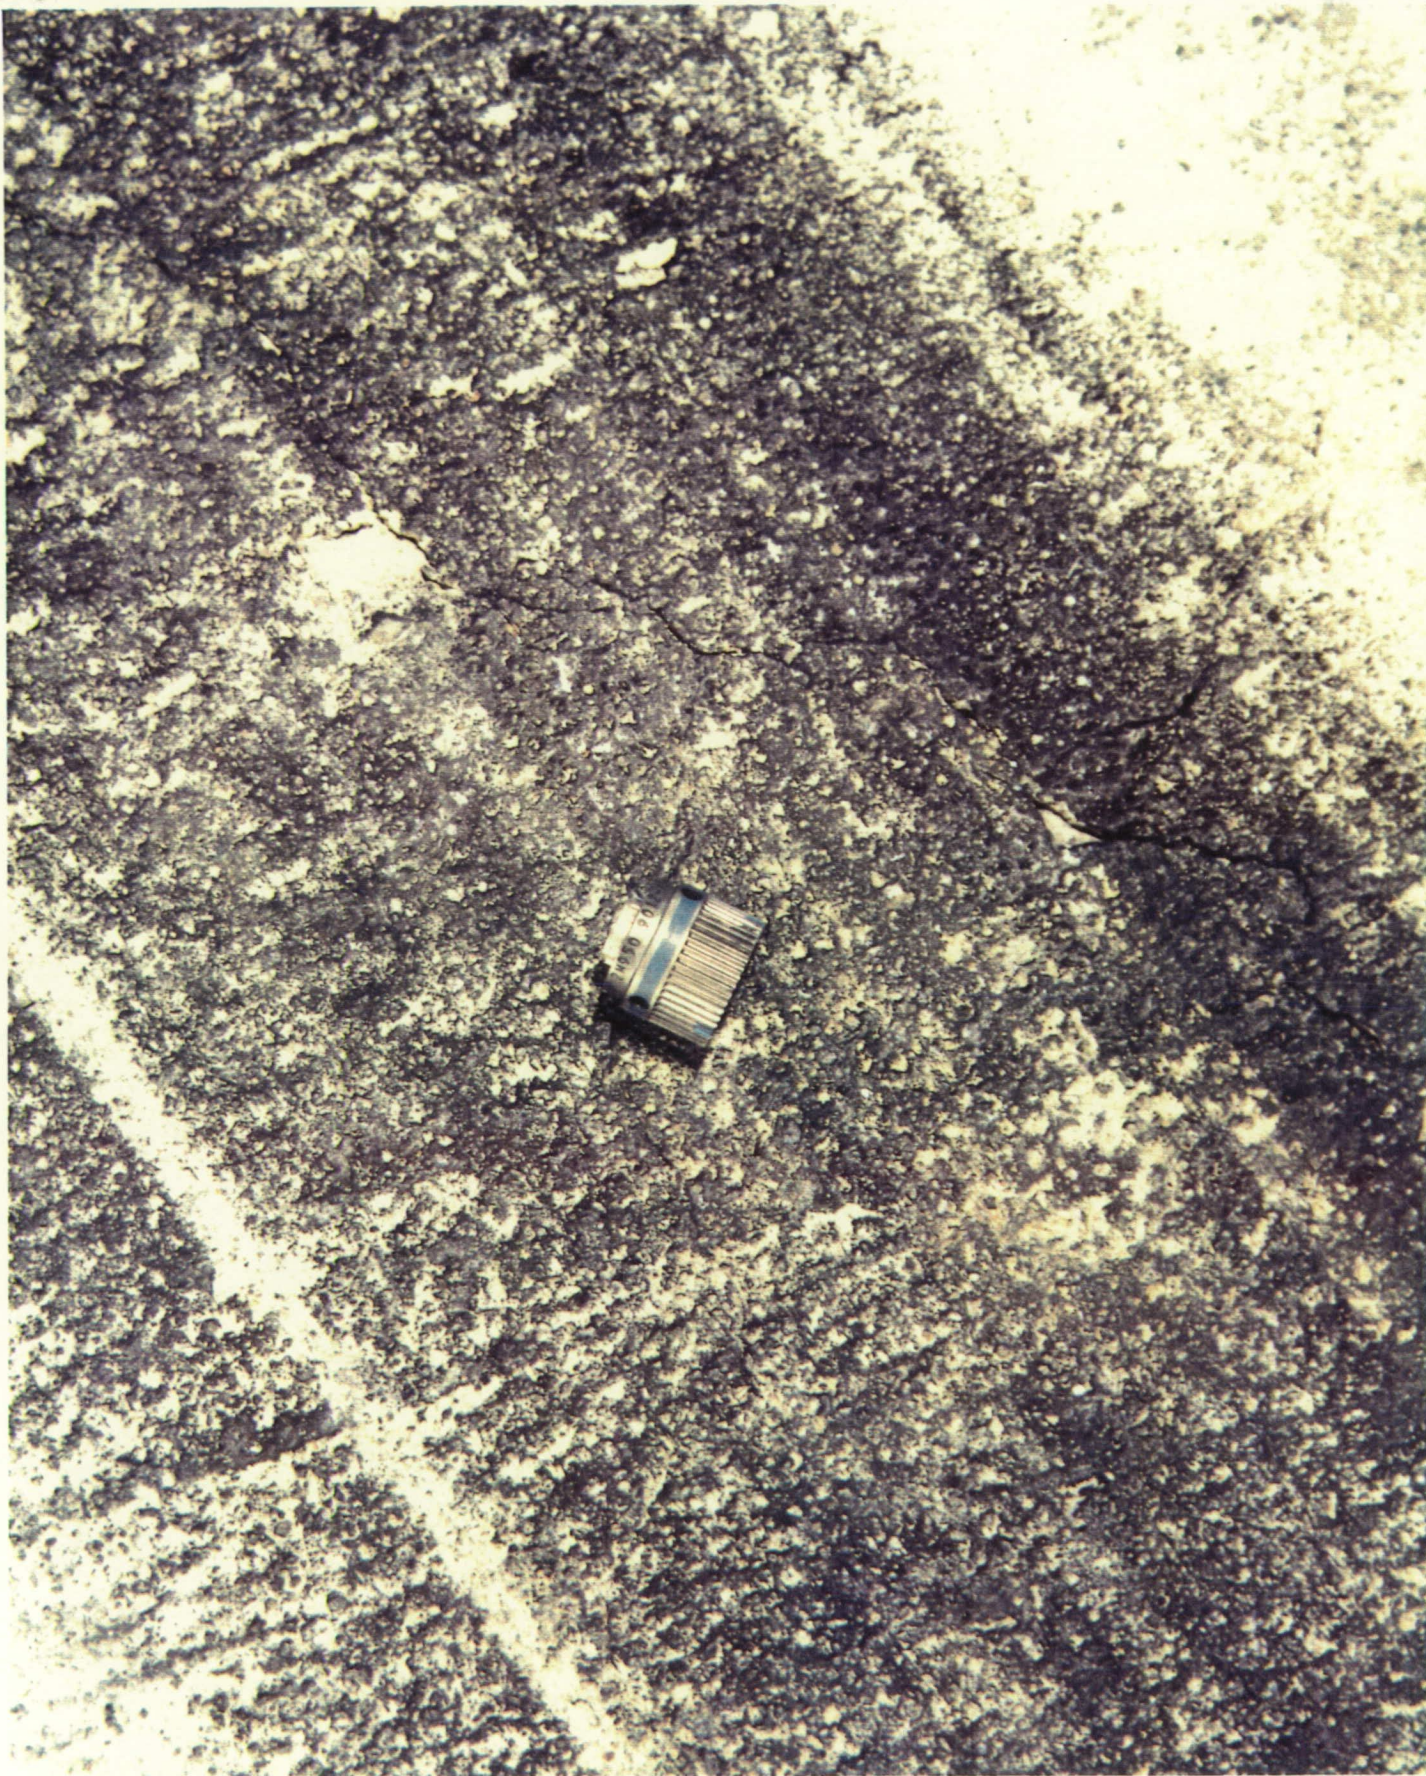
An ordnance connector from the outboard LH2 ET/ORB umbilical separation system fell to the runway when the ET door was opened.

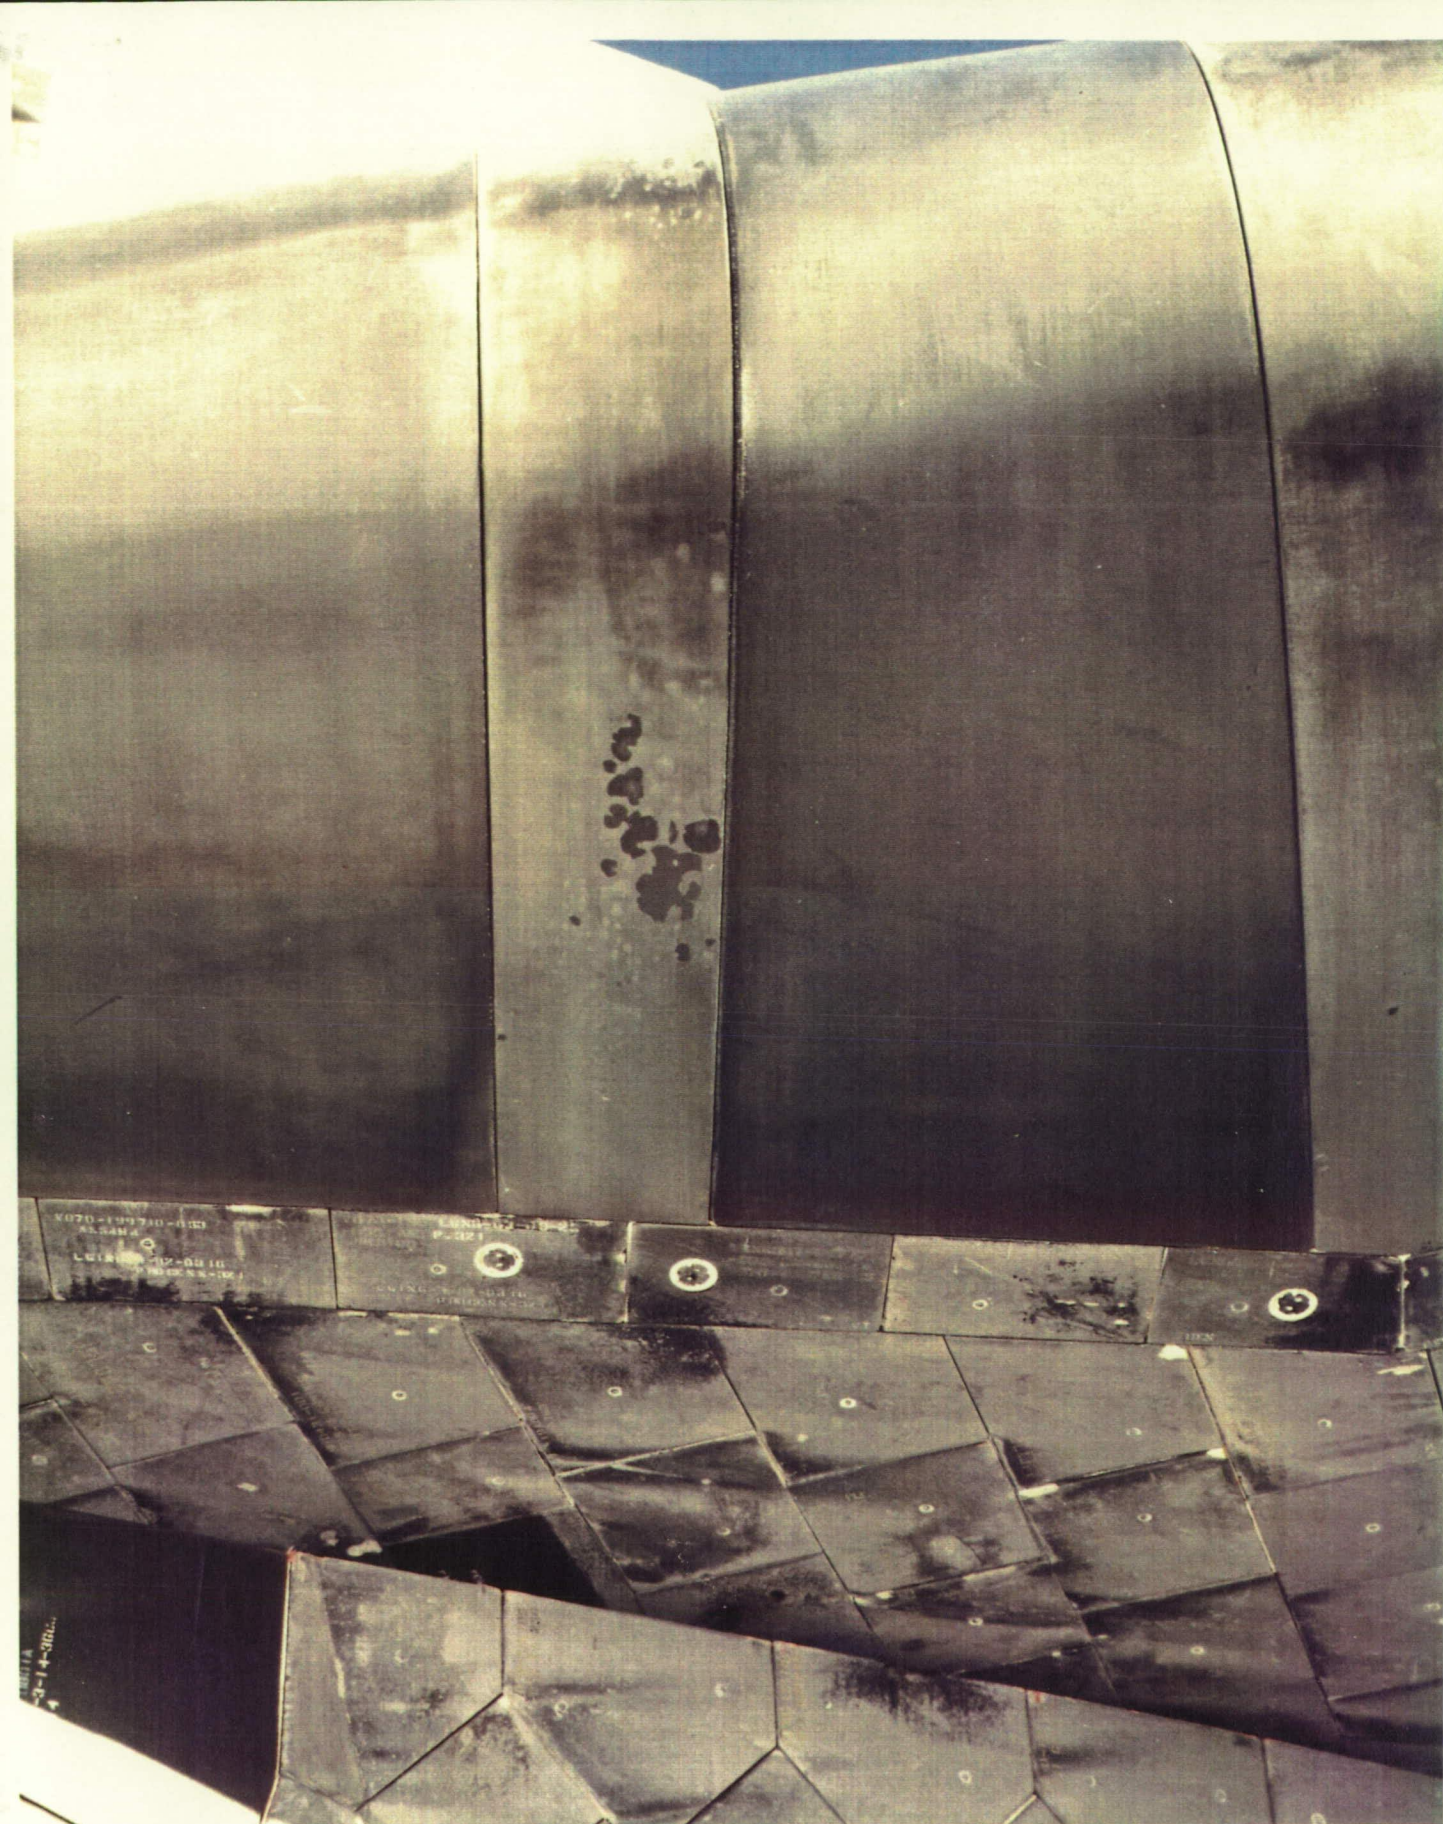
The coating on the LH wing leading edge RCC T-seals #7 and #8 exhibited some blistering and spalling, but was not a debris issue.
